PRE-PURCHASE INSPECTION REPORT

Vehicle: 2024 Porsche 911 Turbo S Cabriolet (992)

VIN: WP0CD2A97RS258043

Company: U.S. Auto Inspection

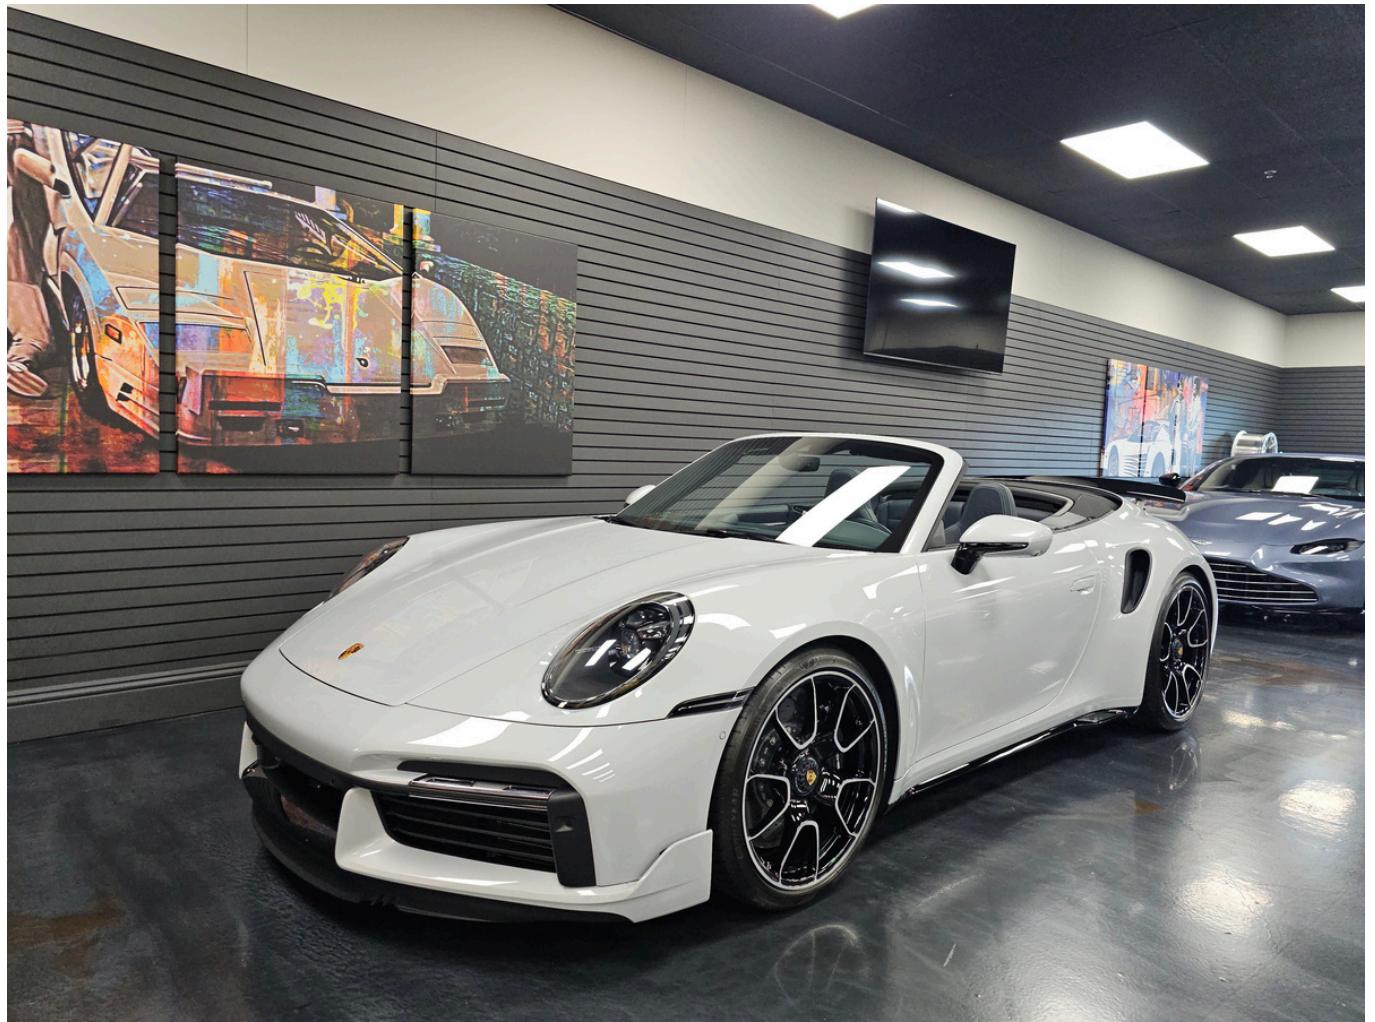
VEHICLE OVERVIEW

The inspected vehicle is a low-mileage 2024 Porsche 911 Turbo S Cabriolet equipped with a 3.7L twin-turbocharged flat-six engine, Porsche Active All-Wheel Drive, and an 8-speed PDK dual-clutch transmission. This model represents the highest performance trim level of the 992 generation, combining supercar-level acceleration with daily drivability and advanced electronic systems.

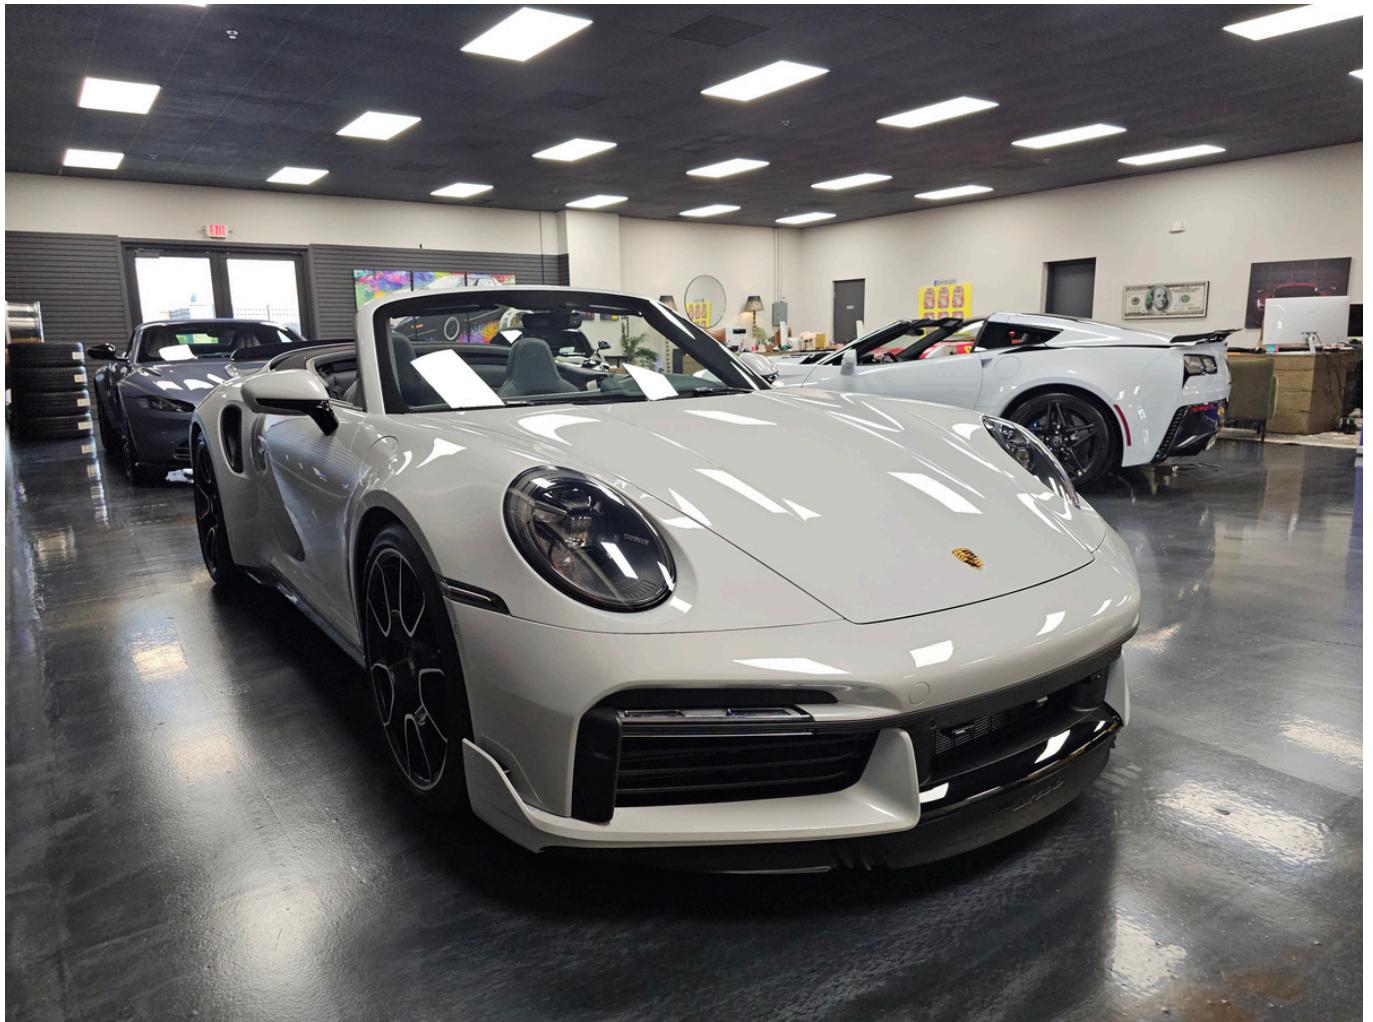
EXTERIOR & BODY CONDITION

Paint finish and body panels present in excellent condition with consistent factory gaps and alignment. No evidence of repaint, structural repair, corrosion, or cosmetic damage observed. All lighting systems, trim components, glass, and aerodynamic elements (including active rear spoiler) are properly installed and functioning as designed.

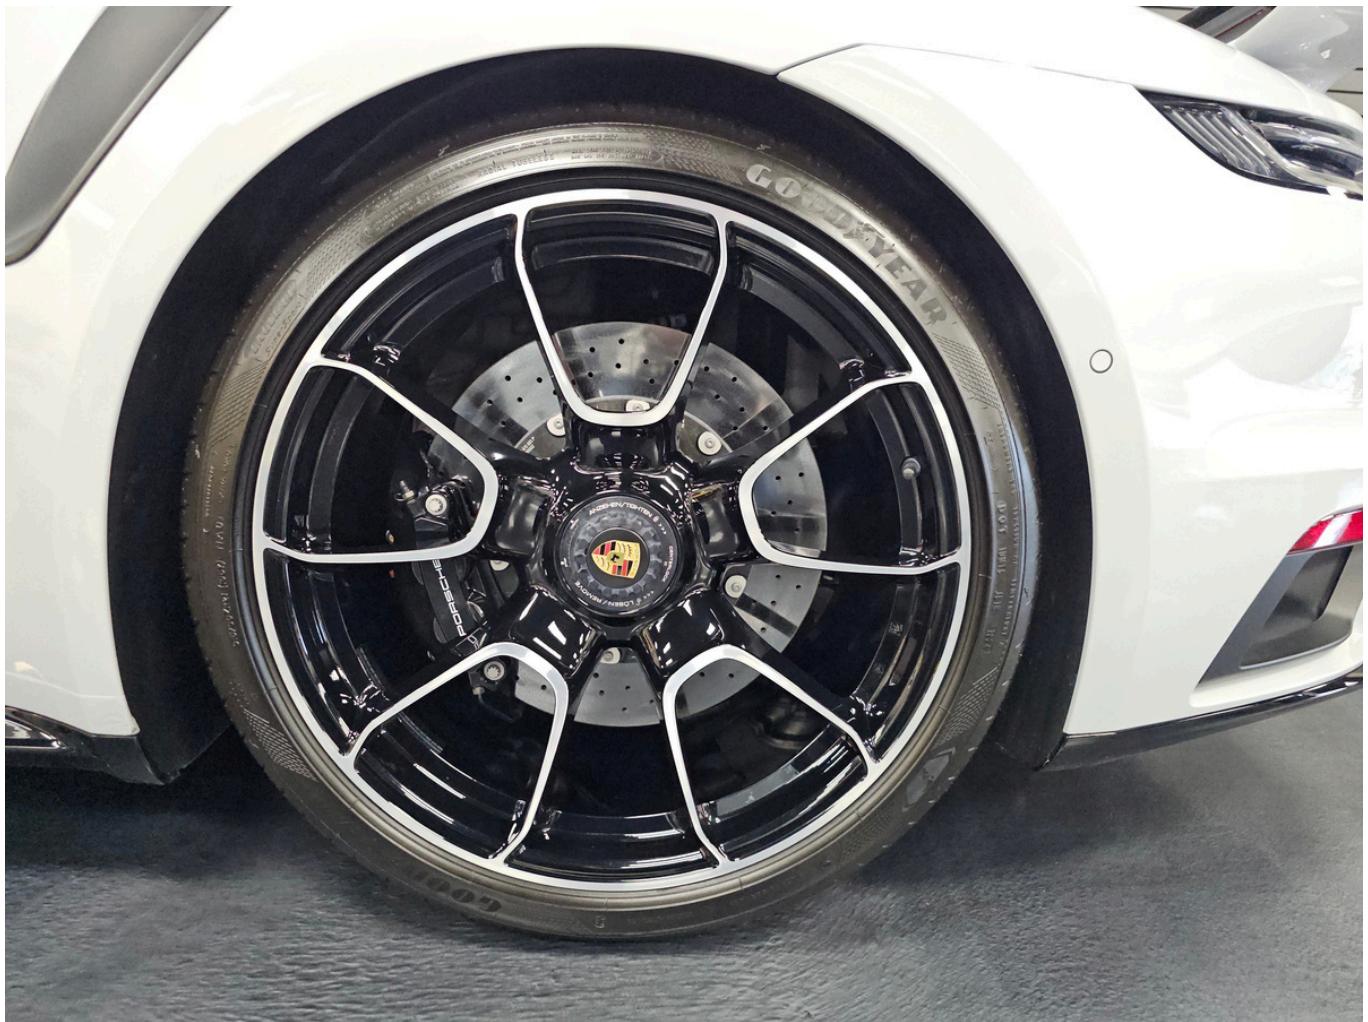
WHEELS, TIRES & BRAKING SYSTEM

Factory Porsche alloy wheels are free of curb damage or structural defects. Tires show uniform tread wear and correct fitment.

High-performance braking system inspected visually:

- Brake rotors show no cracking, scoring, or heat stress.
- Calipers are secure with no fluid seepage.
- Pads show minimal wear, consistent with the low mileage.
- No vibration or pull noted during road test braking.

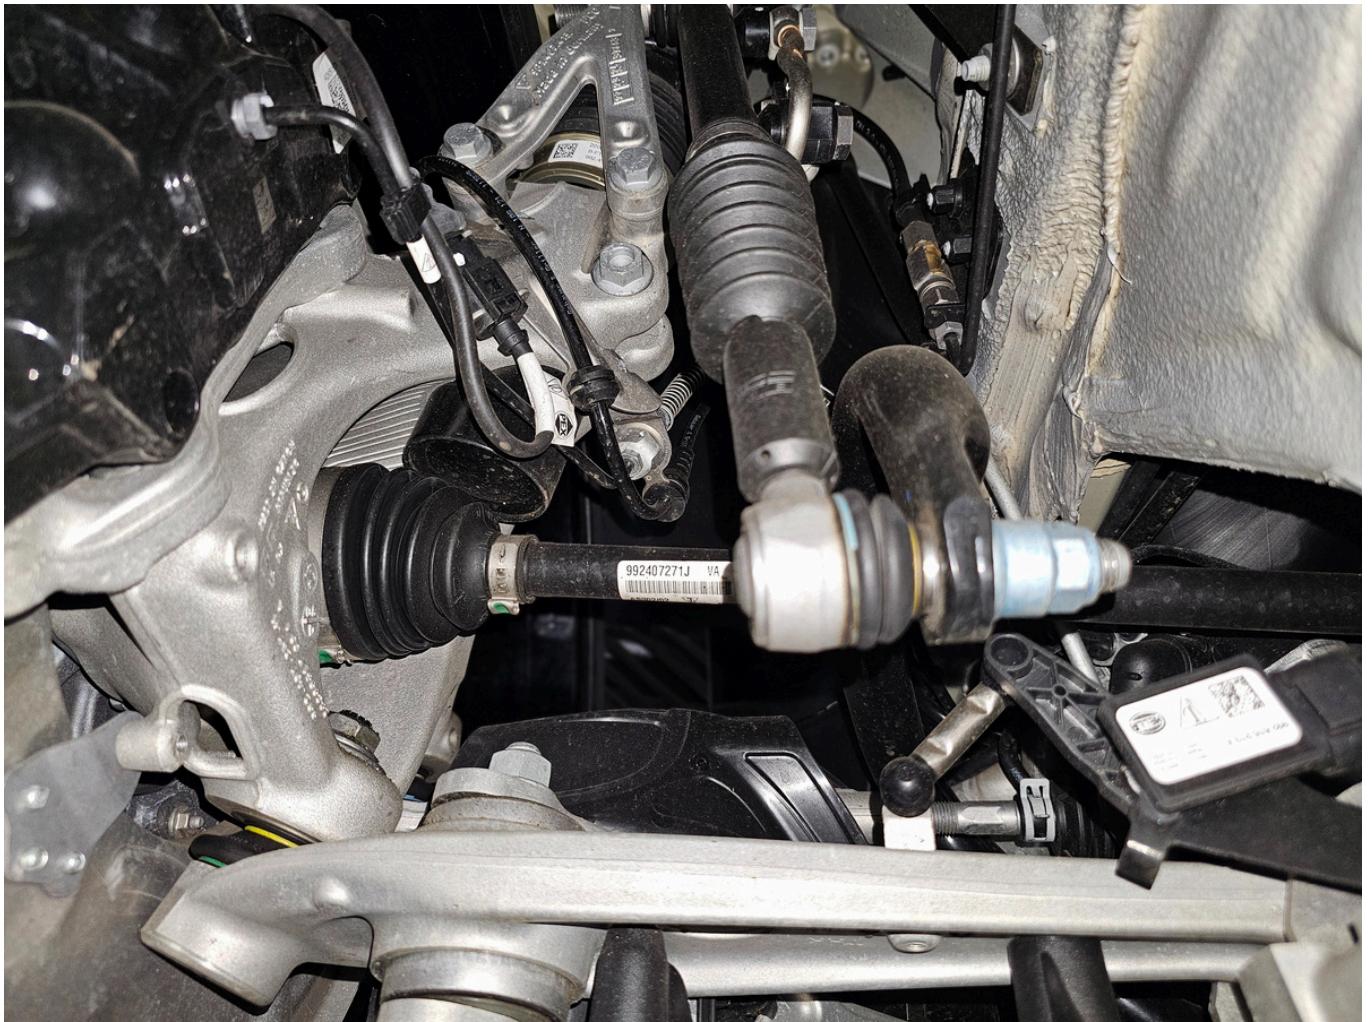
SUSPENSION & STEERING

Control arms, bushings, tie rods, ball joints, and electronic suspension components appear in like-new condition. No abnormal play, leaks, or impact damage observed. Ride height sensors and adaptive damping components are intact and properly secured.

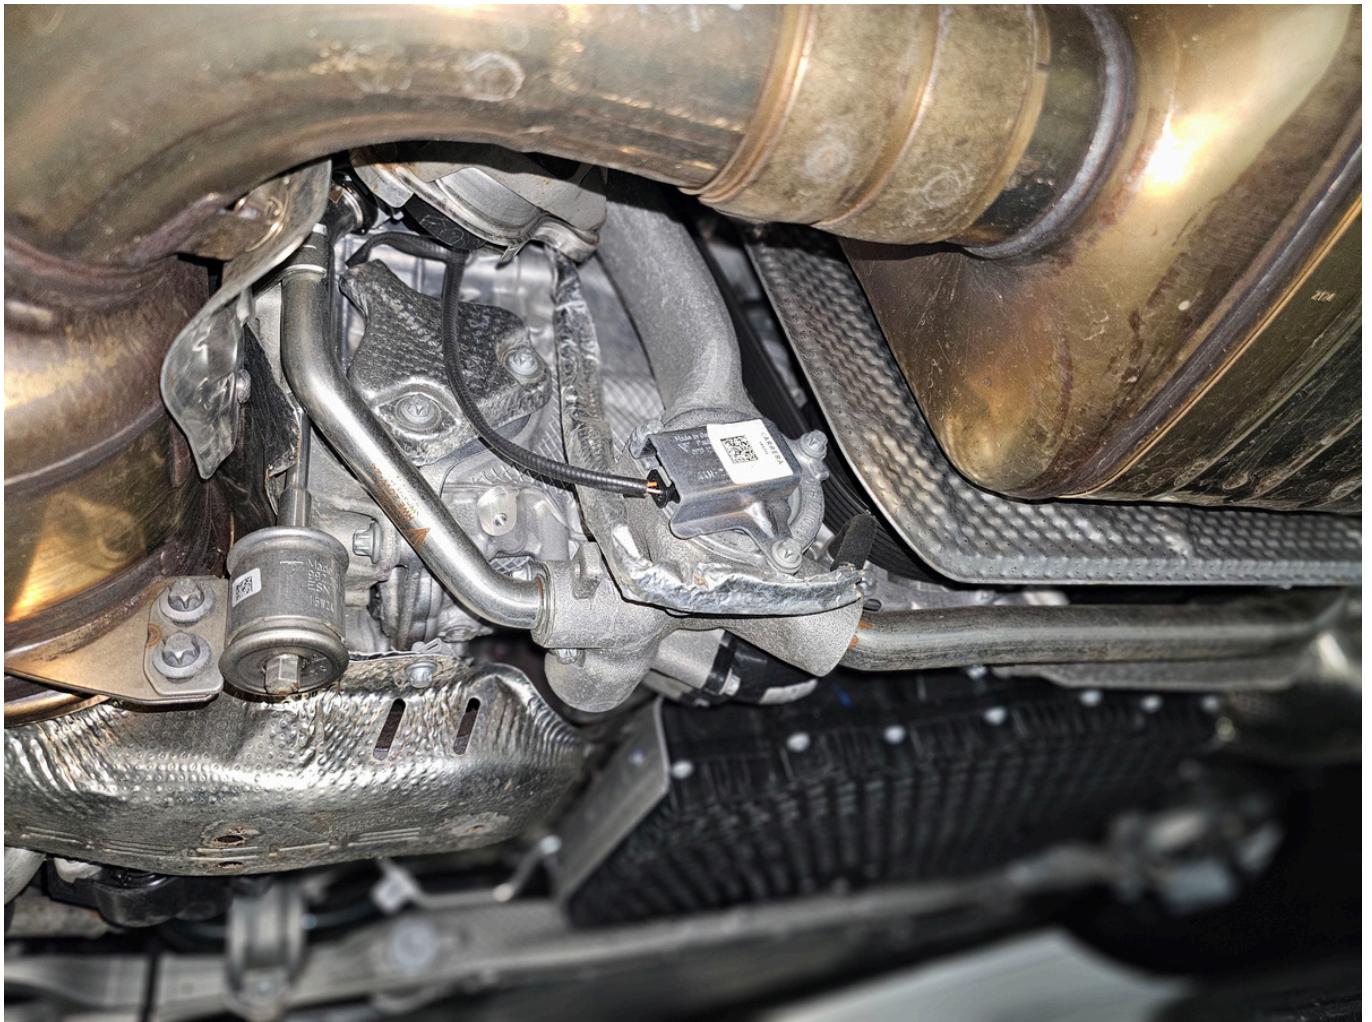
ENGINE & TURBOCHARGER SYSTEM

Visual inspection of the twin-turbo flat-six engine reveals:

- No oil, coolant, or fuel leaks.
- Turbochargers, oil lines, and coolant lines are dry and properly routed.
- Heat shields and insulation intact with no signs of overheating.
- Cooling fans and ducting are clean and undamaged.
- Engine bay presents in factory-original condition.

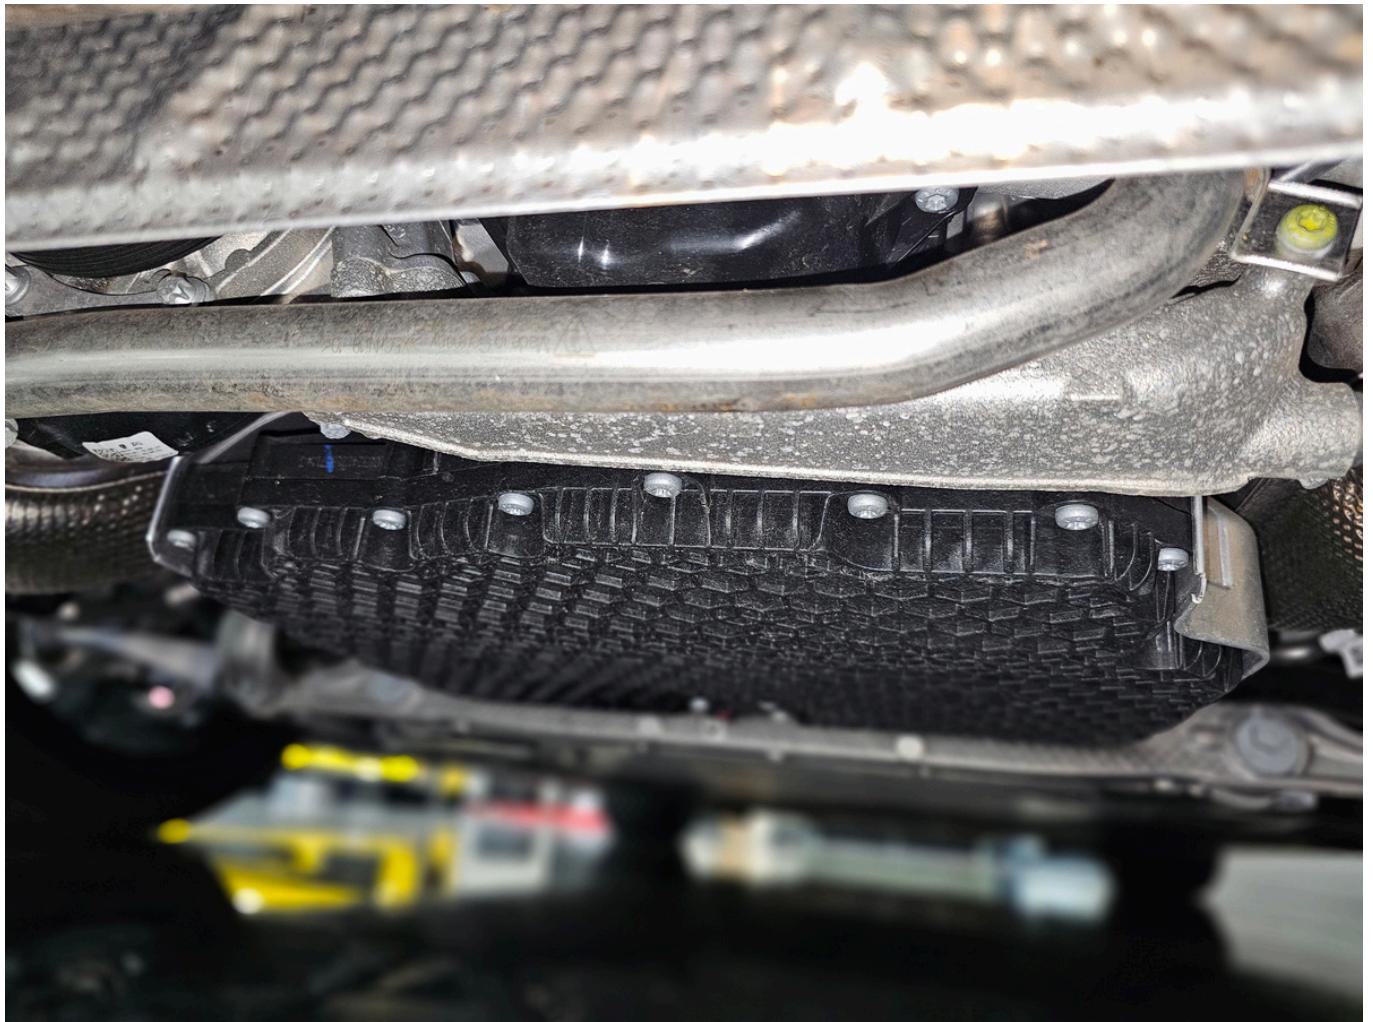
TRANSMISSION & AWD SYSTEM

PDK transmission casing, transfer case, and differentials show no fluid leaks. CV axles and boots are intact with no grease loss. All mounting points and electronic actuators appear secure. No abnormal noises, hesitation, or shift irregularities detected.

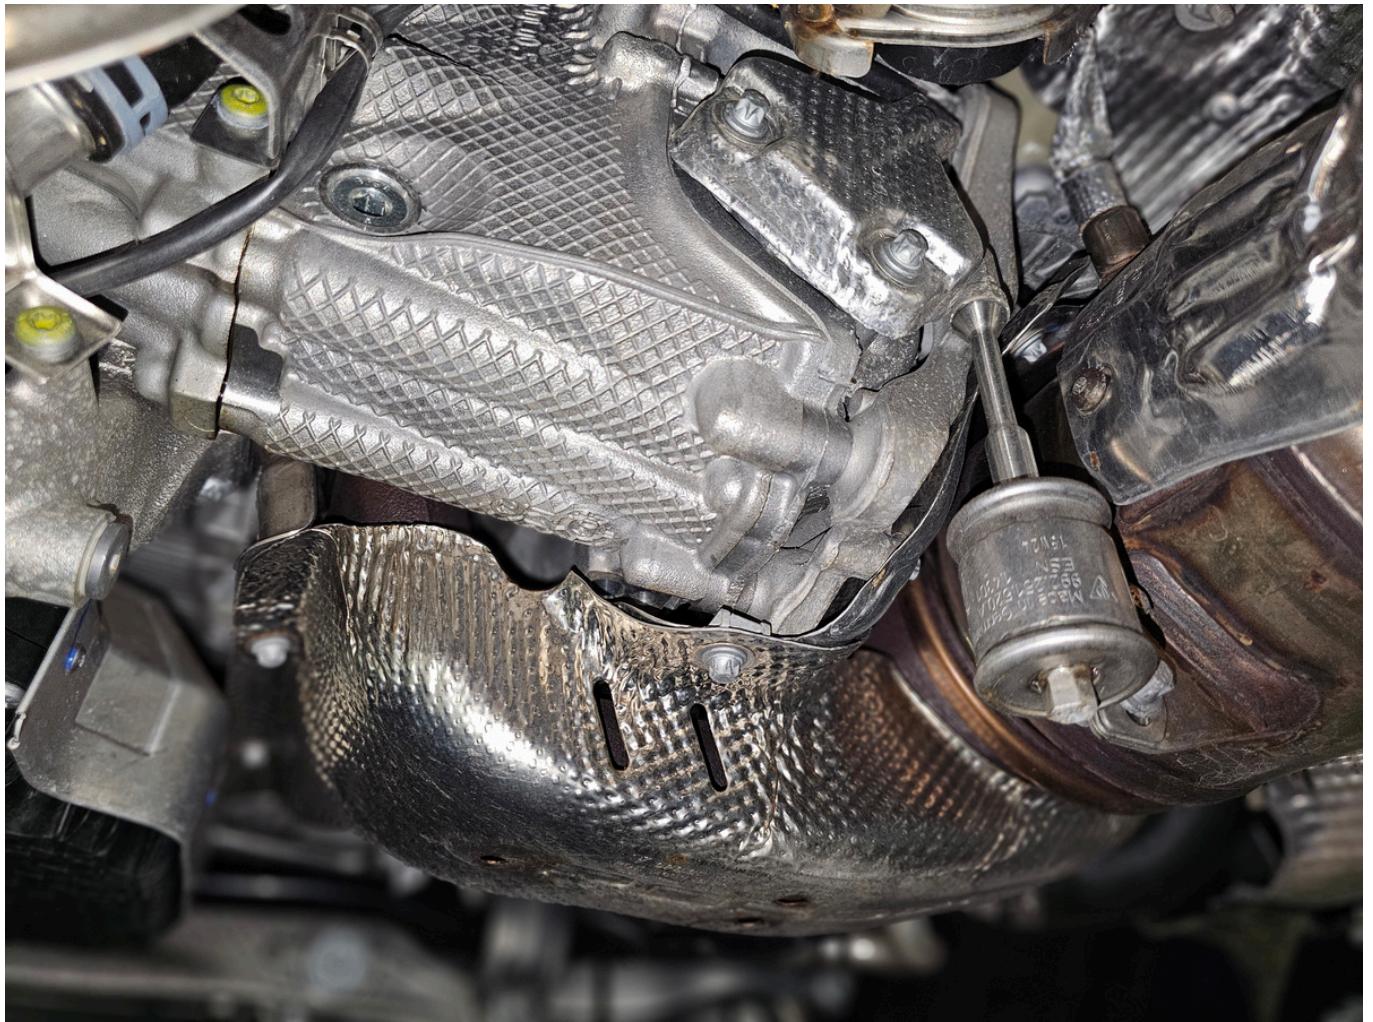
EXHAUST & EMISSIONS

Exhaust system including catalytic converters, valves, and heat shielding shows normal heat coloration with no leaks, cracks, or impact damage. Mounting hardware is intact and properly secured.

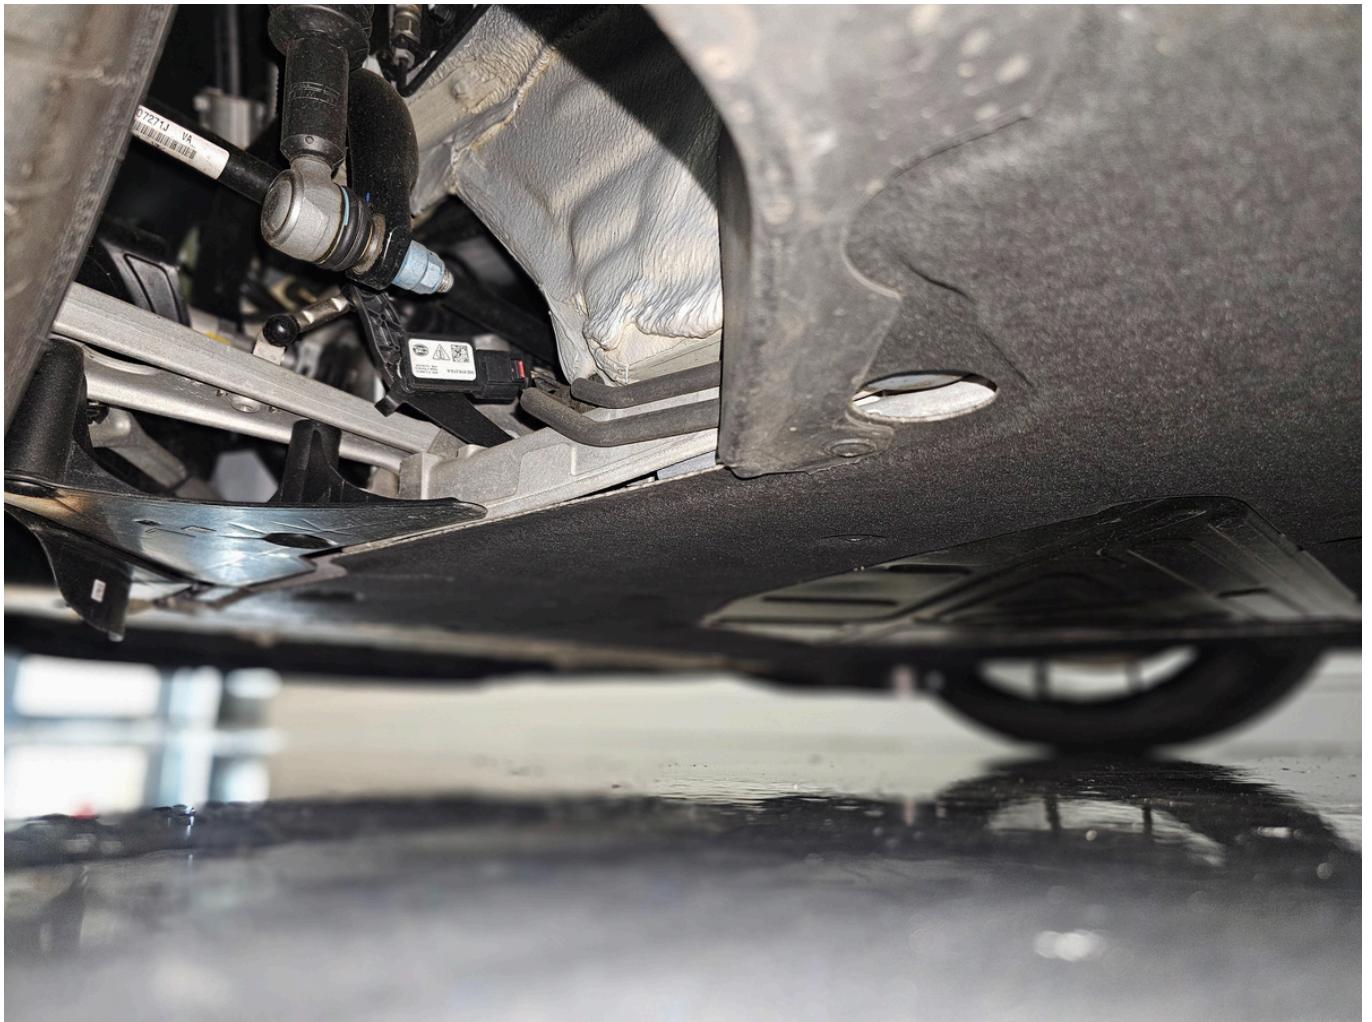
UNDERCARRIAGE & CHASSIS

Underbody panels, aerodynamic shields, and structural components show no scraping, deformation, or corrosion. No evidence of fluid leaks, road impact, or previous repairs.

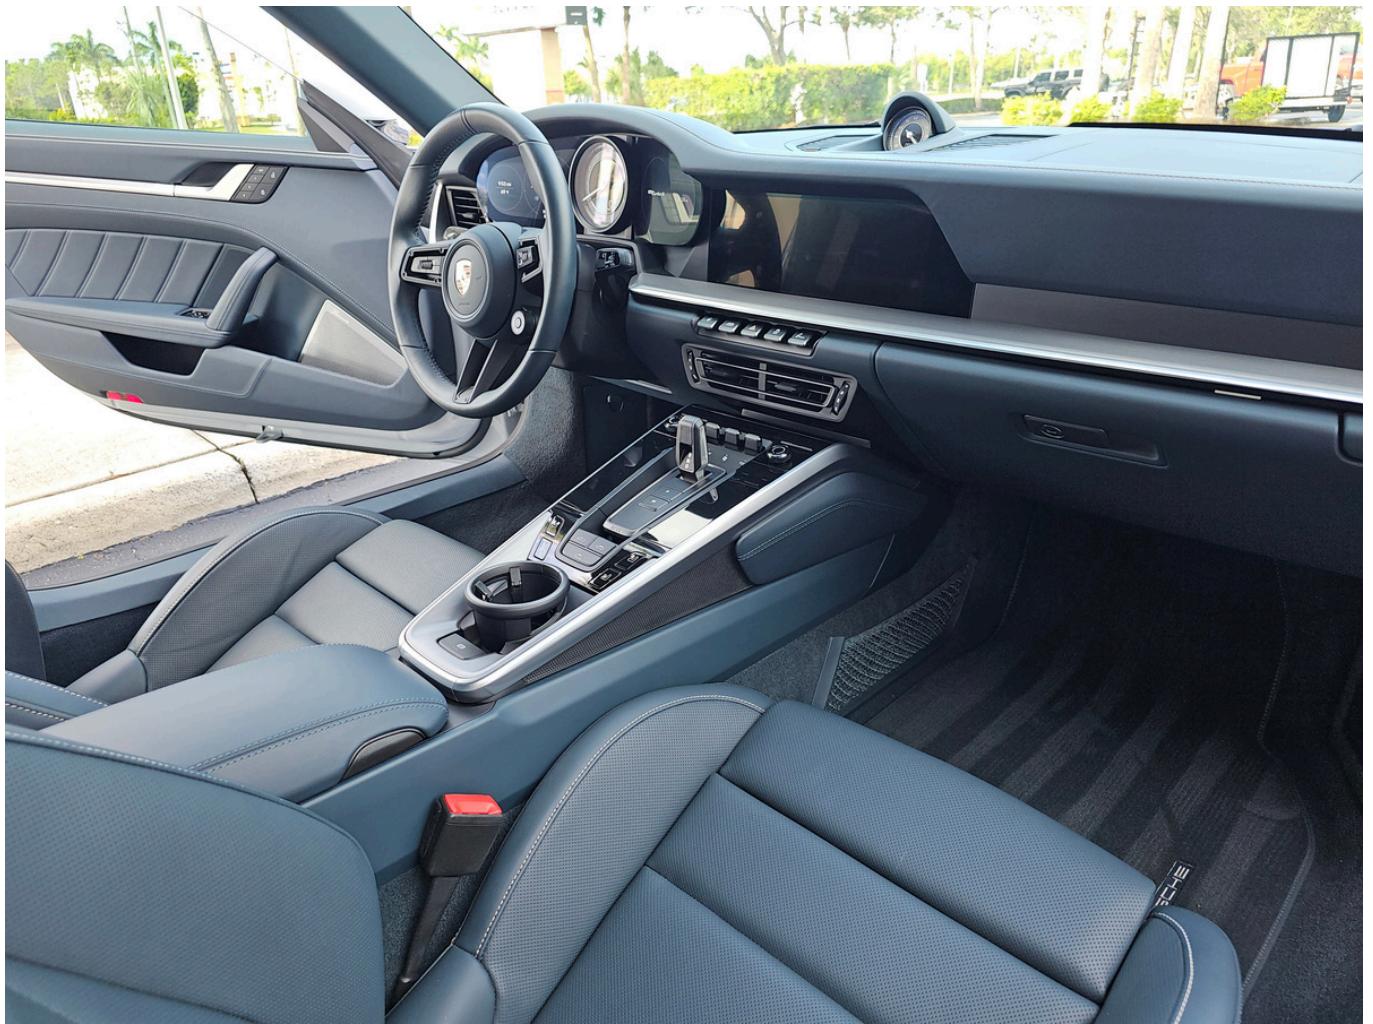
INTERIOR & ELECTRONICS

Interior surfaces, seats, trim, infotainment, climate control, and safety systems operate correctly. Convertible top mechanism and seals function properly. No warning lights present.
